**OTTAWA POLICE SERVICE  
SERVICE DE POLICE D'OTTAWA**

**RE: CPTED Audit (Ottawa Housing Corporation)  
1201 to 1281 Ledbury Avenue  
2070 to 2085 Banff Street**

**Date of Audit: November 29, 2005**

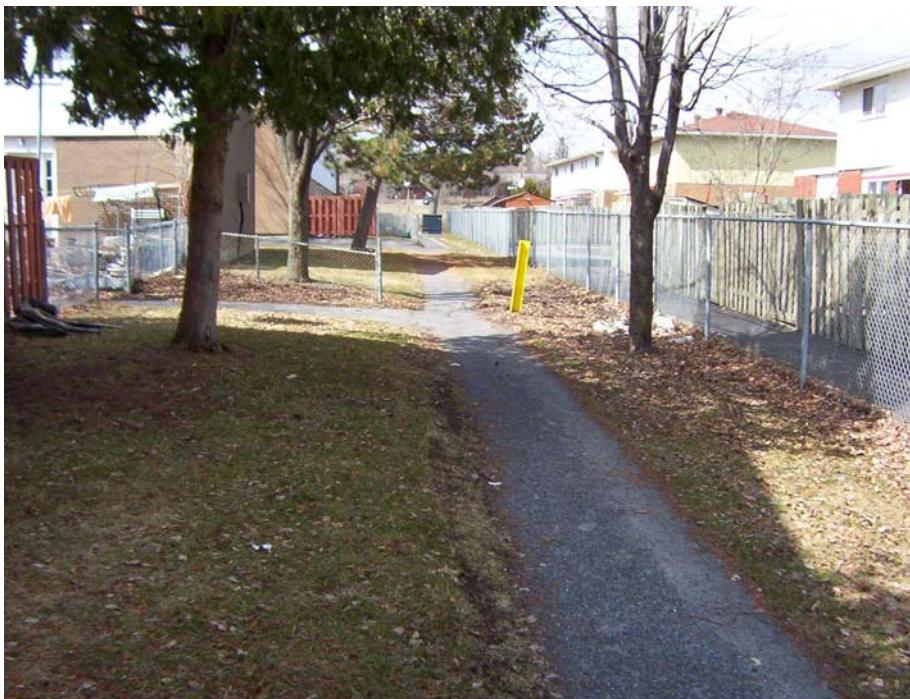
Foot Path at the rear of 1281-F Ledbury Ave. As you can observe, The Private residence to the right separates their property from others using a chain link fence with no opening. This proves to be a very effective way to identify ownership and usage.

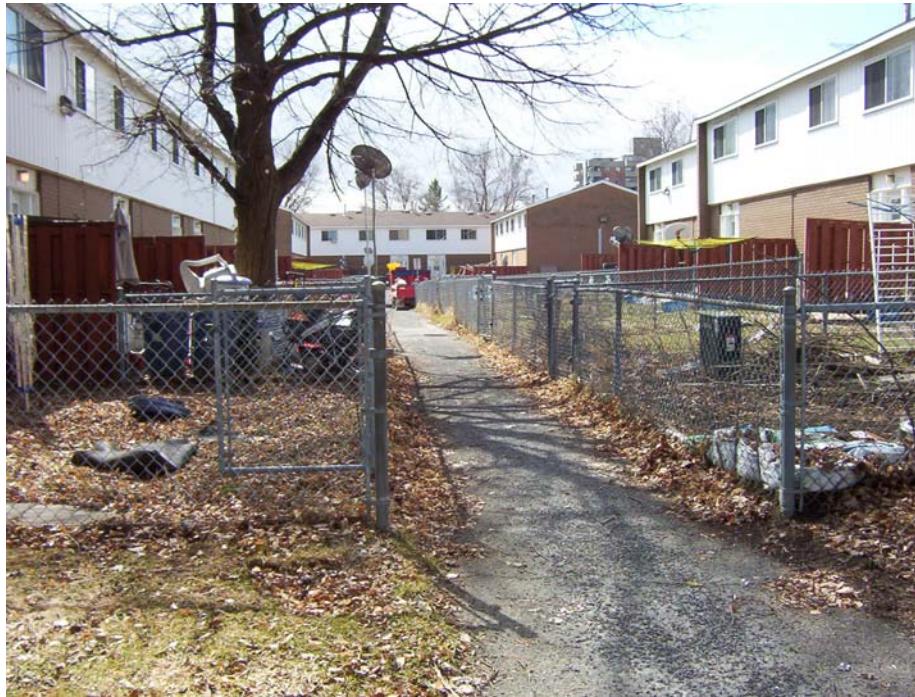
Rear of 1221 A-H & 1217 A-H Ledbury Avenue. Even though each yard is defended by a 4 foot chain link fence, there is no access control and criminal activity takes place on a regular basis.

**Recommendation:** Pathways that run behind the rear of a home should only be accessible by the legitimate user, being the rents/occupiers. Option one the removal of fences all together, blocking access to the back to the rear and creating usable green space. This would greatly reduced unauthorized entry, would create better surveillance of the area and encourage the residents to interact positively with each other.

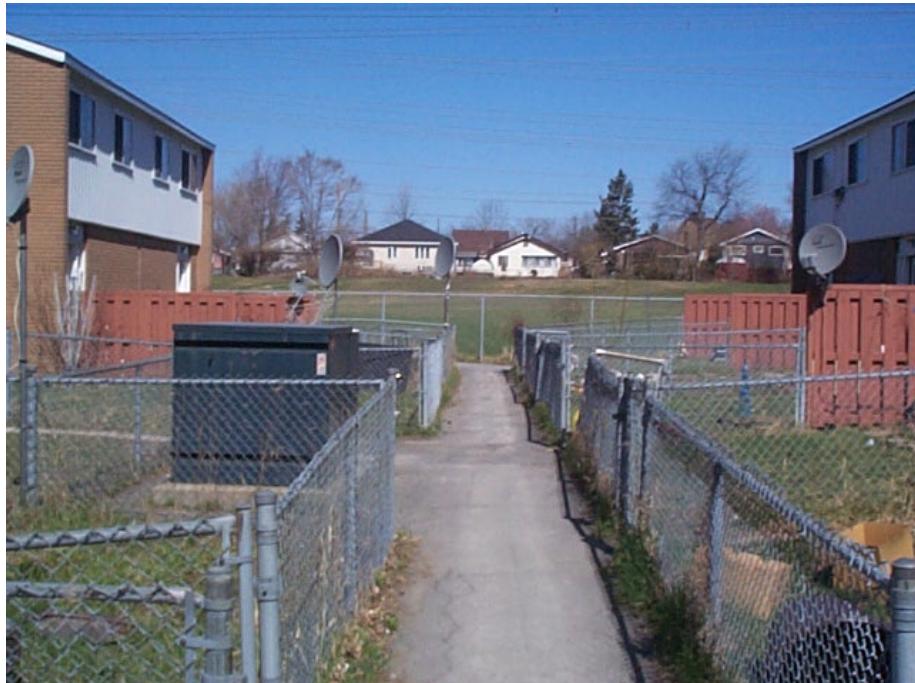
Rear between 1235 (A-E) Ledbury Ave & 2070 (A-E) Banff St.

The entire Ottawa Housing Development share the same characteristics. There are numerous pathways that lead to areas that offers no natural surveillance. The pictures above clearly identify and illustrate the need to create a buffer zone that clearly defines boundaries, private from semi-private to public areas.

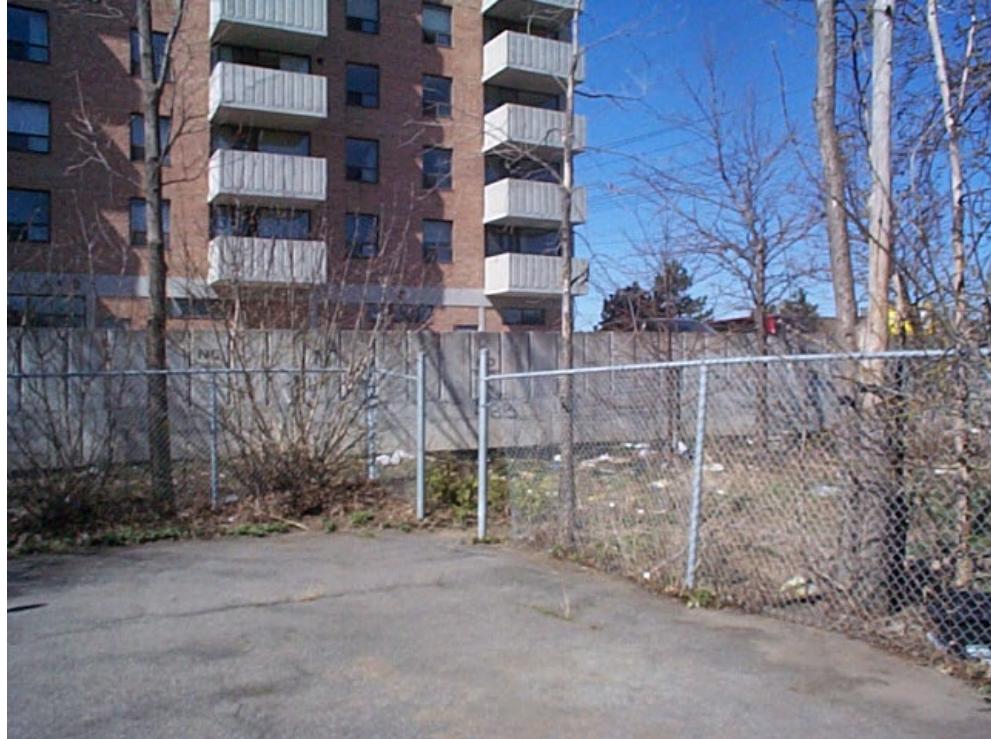
Rear of 1225 Ledbury – access point to hydro field

This area is isolated, extremely poor lighting, no surveillance available and access inviting the public to areas where only legitimate users should be allowed.  
(Numerous assaults and tenant intimidated by gang activities)

Recommendation: Close of access permanently. The area on the other side of the fence is owned by Ottawa Hydro. The public should not have access to area from Ottawa Housing Property.

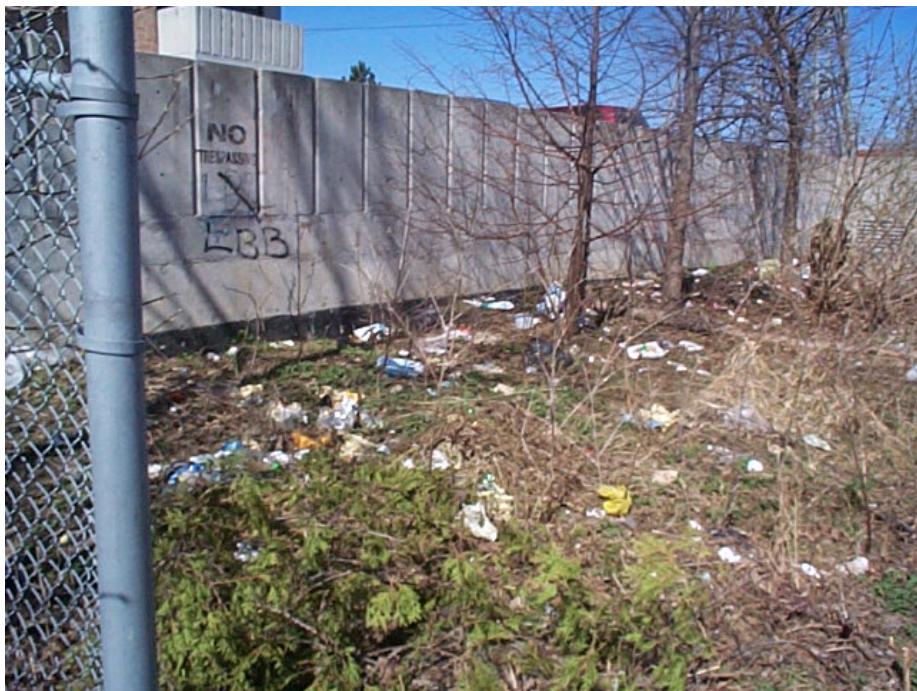
Due to the isolation from the public, it is a garbage-dumping site.

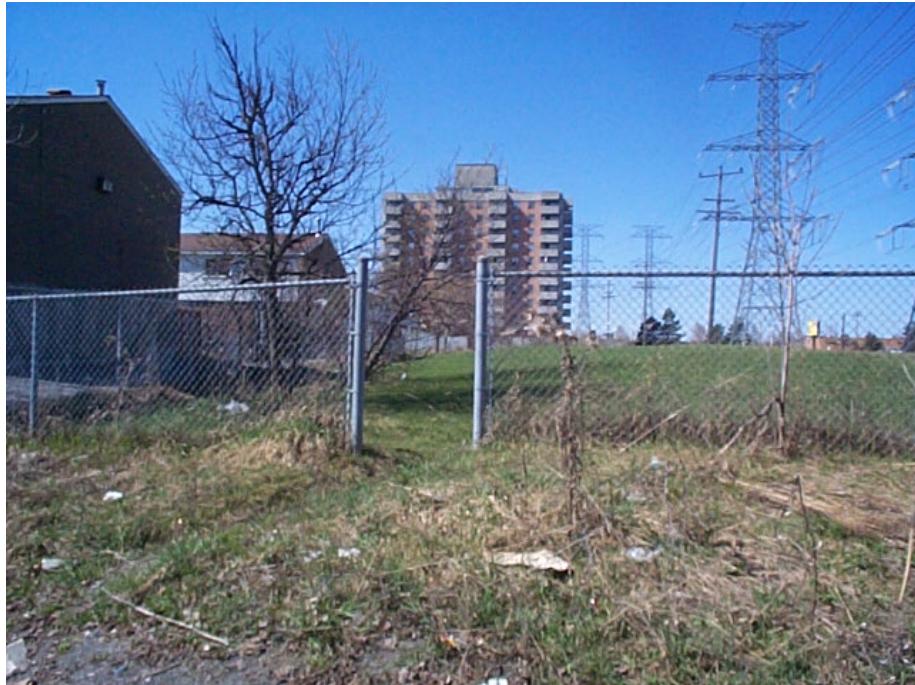
GAPS IN FENCE

The fences along the pathways surrounding the community have gaps built into them in many locations. These exits are frequently used by youths wishing to obtain easy access to the community for the purpose of loitering or “partying” these locations are in areas where lighting and visibility are almost nonexistent, making natural surveillance impossible

**Recommendation:** Controlled access to the rear of units by ways of closing gaps in the perimeter fence. This would greatly reduce / prevent un-authorized access. If exits were required, placing them in areas that would provide natural surveillance of the area. Erecting proper signage and providing educational material to the residence.

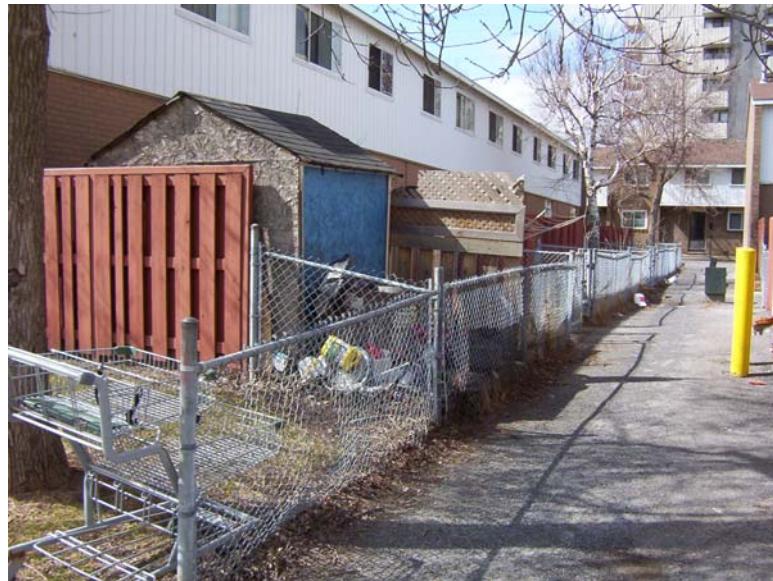
During the summer months the foliage along the fence line becomes thick which could pose a potentially be hazard during the night, due to poor lighting.

**Recommendation:** Encouraging residents to clean up a care for their property might increase the community's general sense of pride through reinforcement, making positive change easier. The second option is to create a green space environment by removing the fence like enclosure. This would create a less cramp looking surrounding.

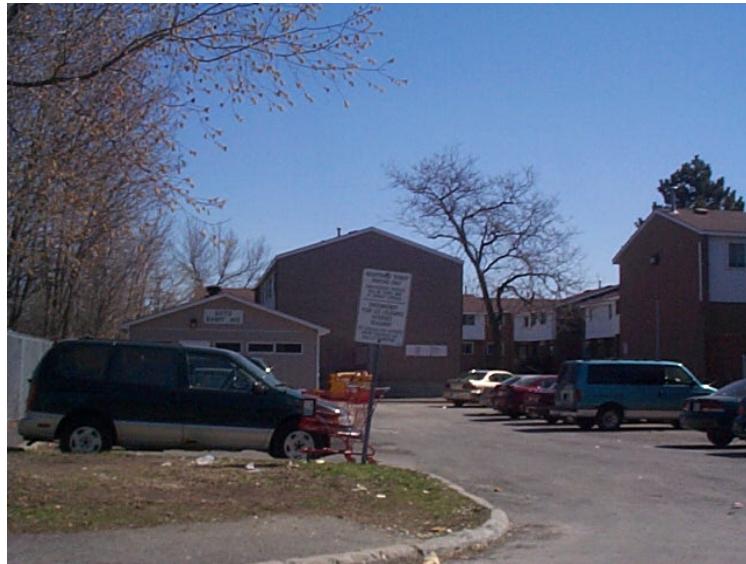
Shop – 2073 Banff Street

Ground Maintenance, which is presently sub-contracted to the private sector, should be better supervised. Currently during the winter months, various pathways are covered with either ice or snow. During the summer months the lawn care are inadequate.

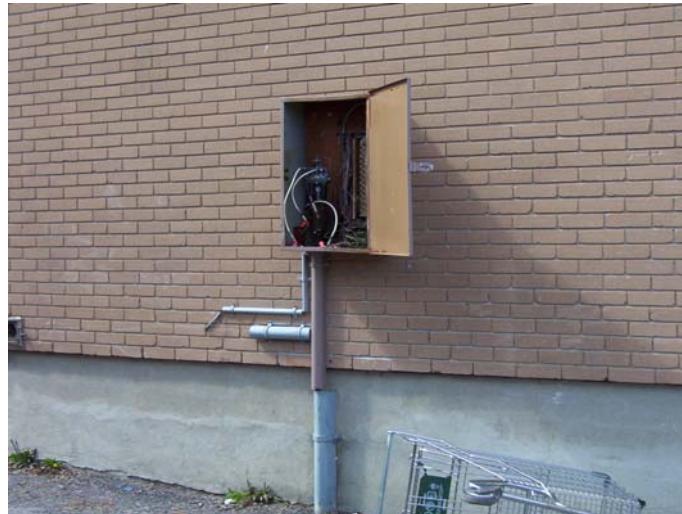
Cable Box

A majority of utility boxes, encountered during the course of the audit had been broken open. It should be noted vandalism of cable boxes is a commonplace in this development.

**Recommendation:** A simple solution would be to relocate boxes to a higher location on wall or a more secure box with better locks as well.

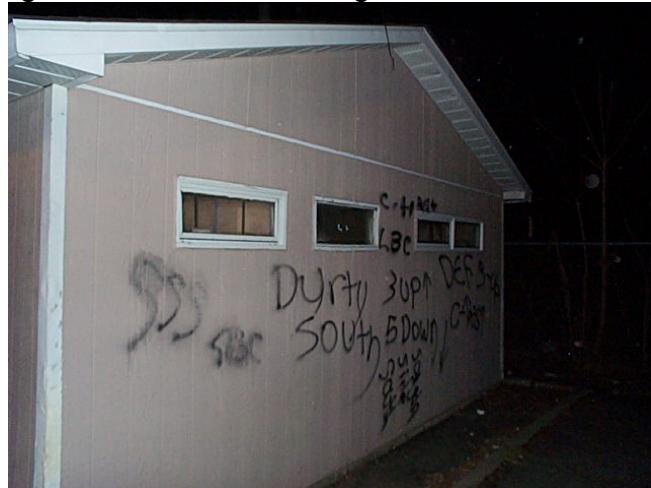
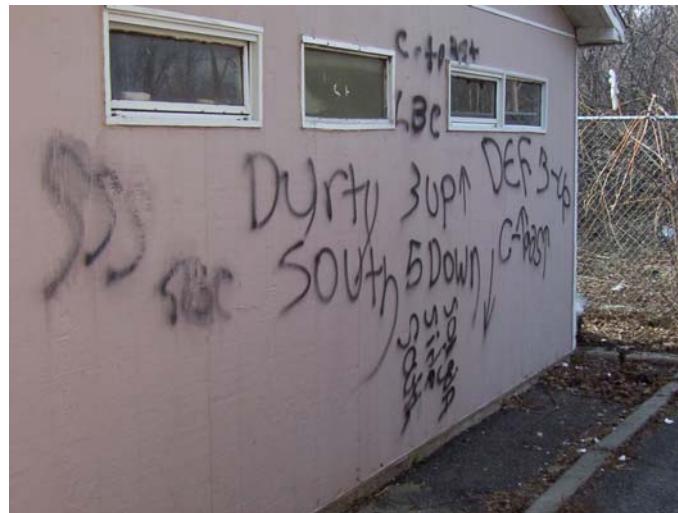
The poor light condition and the lack of natural surveillance increase the opportunity for crime to take place.

Night View of Shed. No lights to illuminate area.

Prominent graffiti was present on the back of the maintenance shed located at 2073 Banff Ave. That area has extremely poor lighting and is concealed by the shed. During the summer months the foliage is thick and dense. At night the parking areas are well lit, however the path/walk way that leads behind the shed is in darkness. The graffiti are tags re-enforcing the presence of youth gang activities.

**Recommendation:** Relocating of shed, cutting back foliage and limit access to the rear by reducing pathways. The City should partner with Ottawa Hydro, who owns the hydro field that borders the city property. (**See attached site plan-beside 1267 Ledbury Ave.**) Close access to the rear pathways to the public/close access to the hydro field.

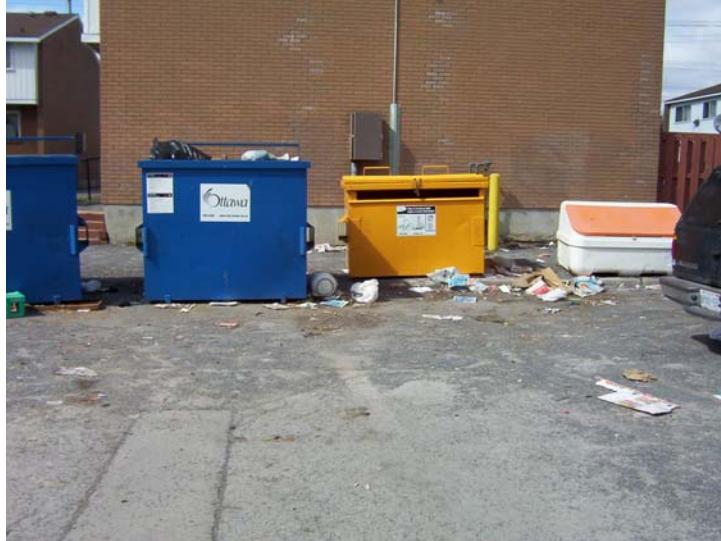
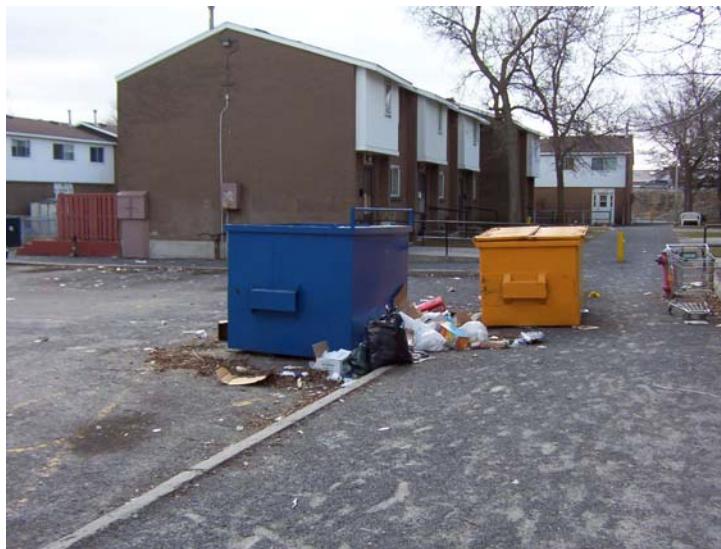
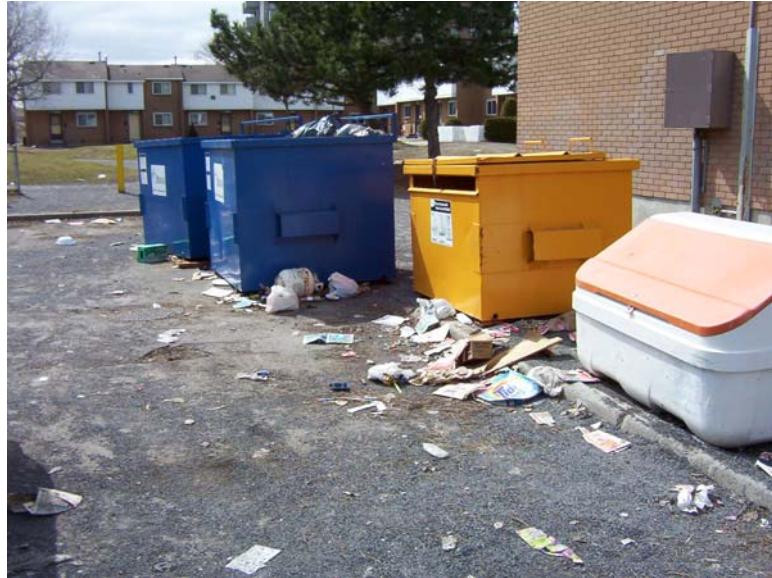
Small garbage receptacles throughout the complex would encourage residents and visitors to dispose of their refuse properly. Due to the size of the Ledbury area the garbage bins provide are unsuitable to service this large group of residents. A cleaner tidier environment will create a sense of pride in those who live there.

**Recommendation:** Ensure they are always secure and enclosed in a fence enclosure. Larger garbage bins or having more garbage pickup days. Smaller garbage receptacles throughout the complex will greatly reduce visual pollution.
